ExpoSolar[®] Colombia 2019

Quality management of supply chain for PV power plant

Supply chain of PV power plant development

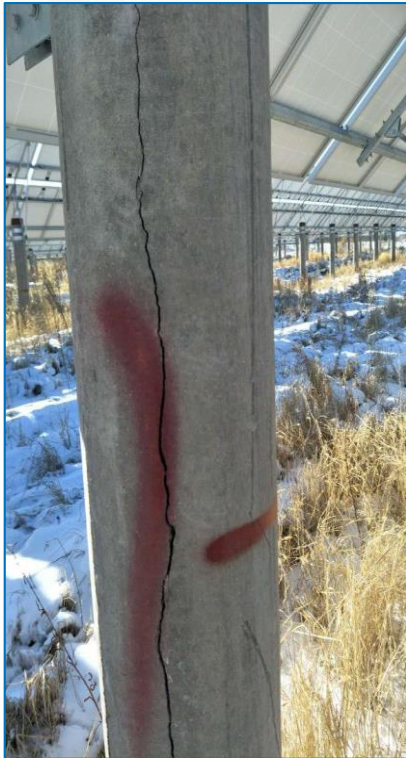
Foundations

Quality management of supply chain for PV power plant development – Example equipment failures

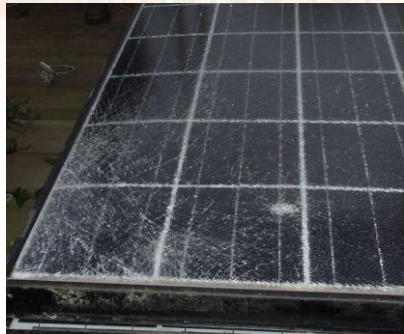
Glass breakage

PV Module Product Quality - Examples for PV module failures

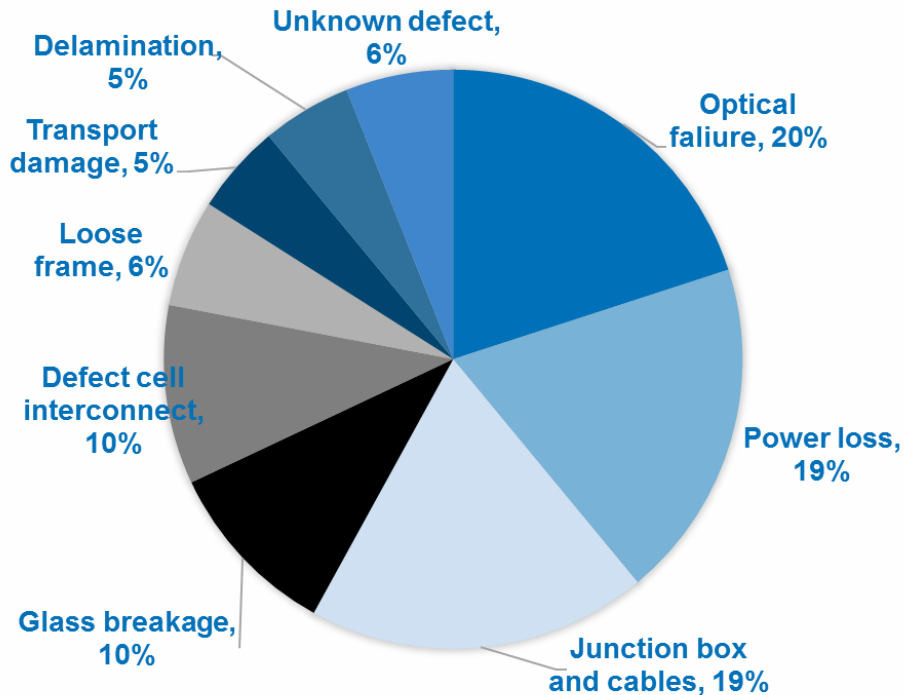
Failure rate from warranty claims
(2011~2013)

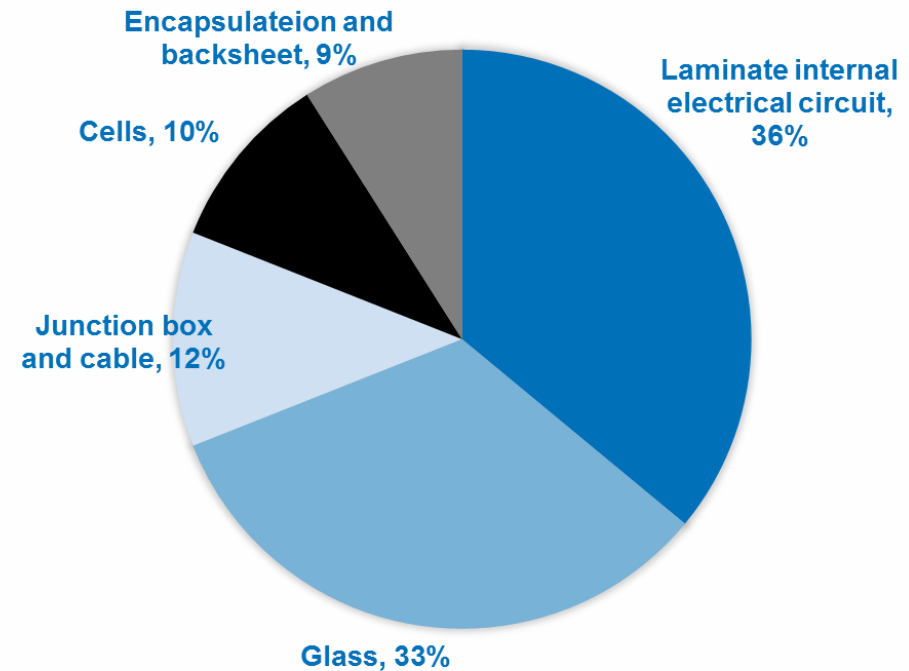
Failure rate from field studies (8 years, 21 manufacturers)

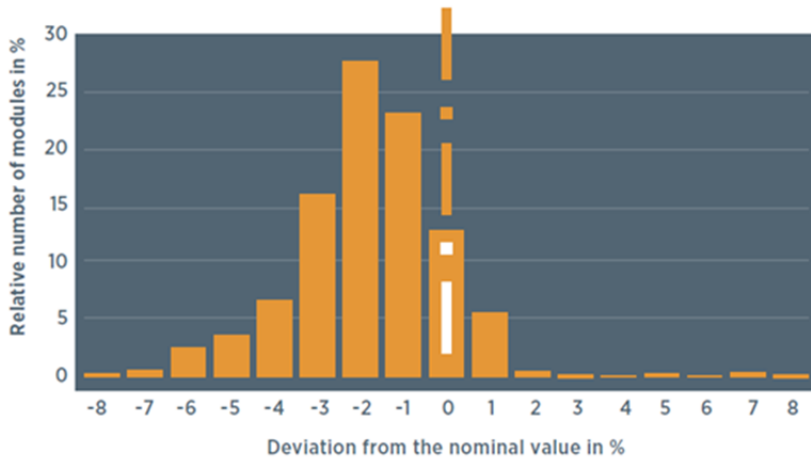
DEVIATION FROM THE NOMINAL VALUE
(LARGE-SCALE PROJECTS USED; 51 MODULE TYPES)

Left: Module Manufacturer were not aware of independent measurement
Right: Module Manufacturer has been informed about independent measurement

Example:
One percent power deviation
of a 100 MWp PV power plant
(investment 100 Mill €) can lead to
3 Mill € revenue losses

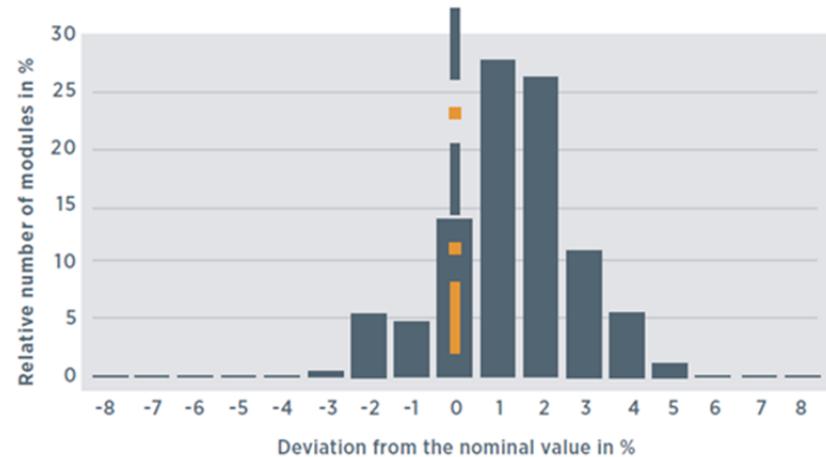
DEVIATION FROM THE NOMINAL VALUE
(LARGE-SCALE PROJECTS NEW; 16 MODULE TYPES)
